Report No. CG-D-02-98

IMPROVED INSPECTION OF WOODEN VESSEL FASTENERS

U.S. Coast Guard
Research and Development Center
1082 Shennecossett Road
Groton, CT 06340-6096

Final Report
August 1997

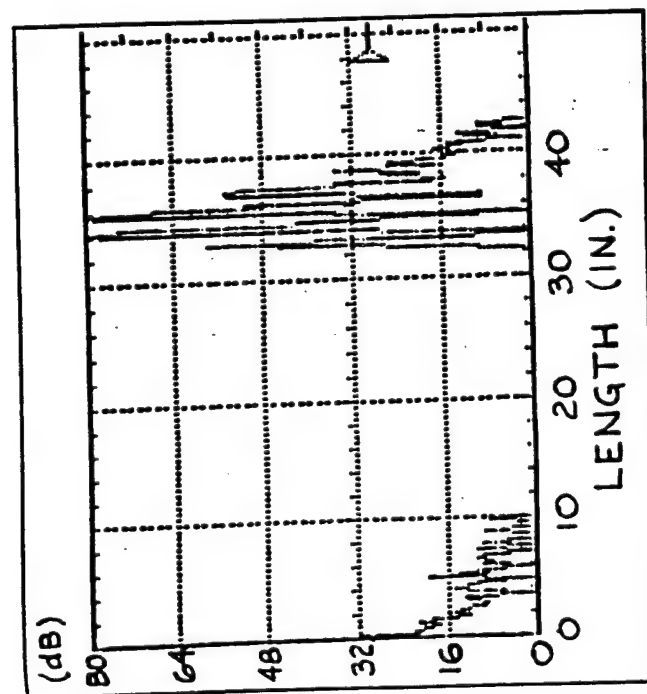
FIGURE 4. Ultrasonic Output Showing a Good Fastener

A-scan of 32-inch long copper alloy drift pin in the starboard sister keelson (sail locker area). The pin is in good condition with light wastage on the inboard 8-10 inches.

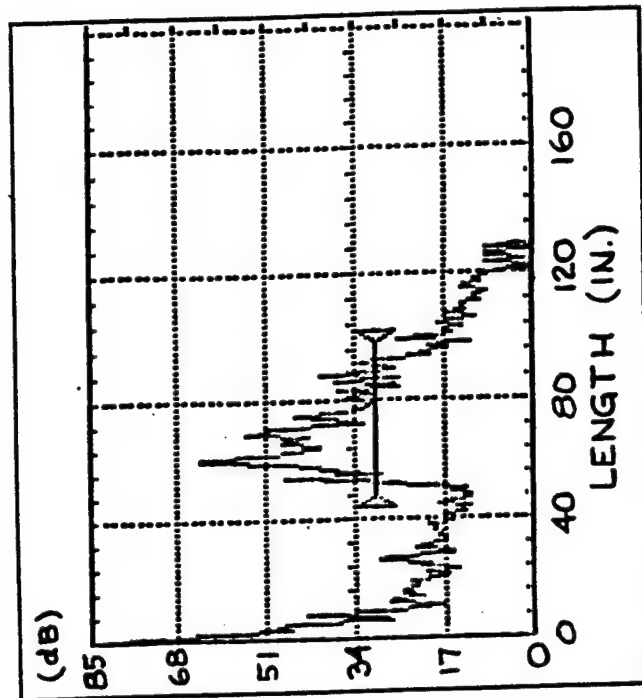
FIGURE 5. Ultrasonic Output Showing a Bad Fastener

A-scan of lower breasthook centerline fastener in the oil locker. The absence of a backwall indicates that this fastener is defective.

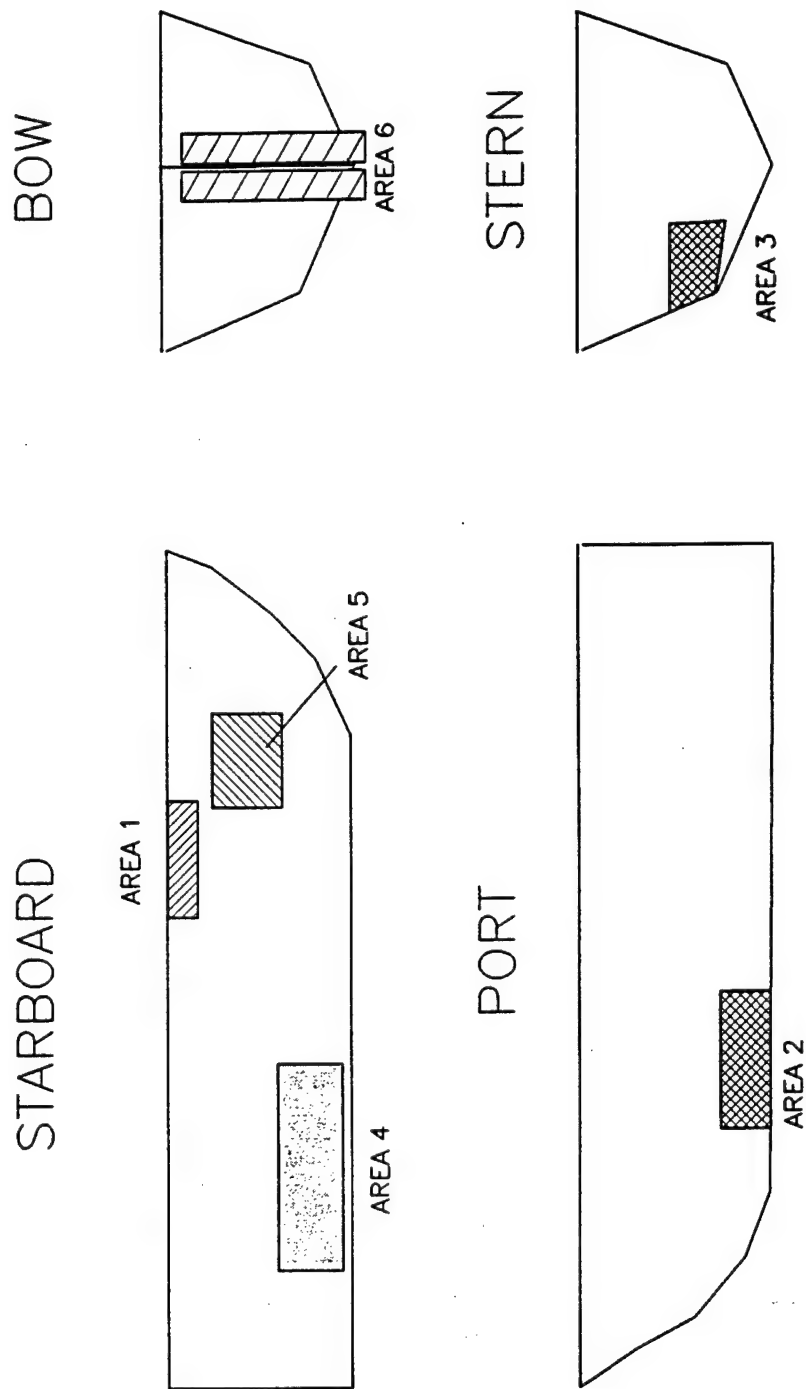
FIGURE 14. Test Area Locations

The surveyors were asked to identify typical types of trouble spots which they would like more information about if they had a nondestructive test method available. They were also asked to identify areas which appeared in fairly good condition to be used as control areas. The areas designed at test locations are shown in Figure 14 and described below:

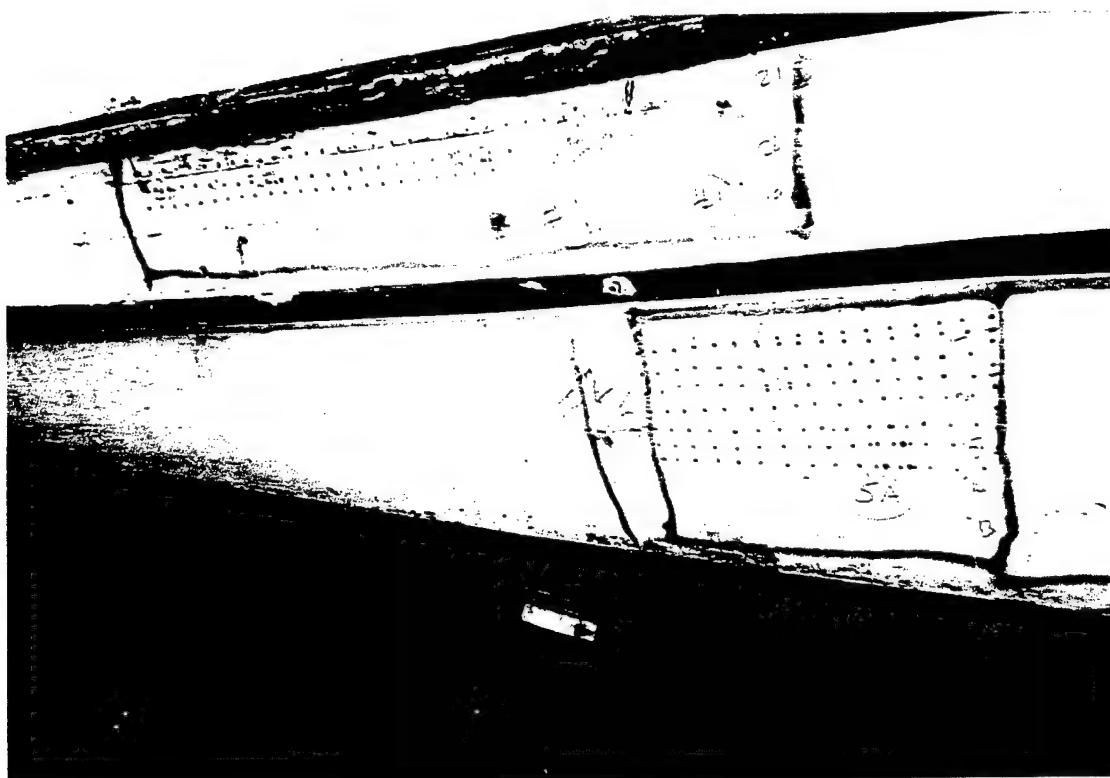
FIGURE 15. Photograph of Test Area 1

<u>Area</u>	<u>Description</u>
1.	A five foot long area just below the rub rail. The condition of the area ranges from good to a hole which has been created due to rot. (Figure 15)

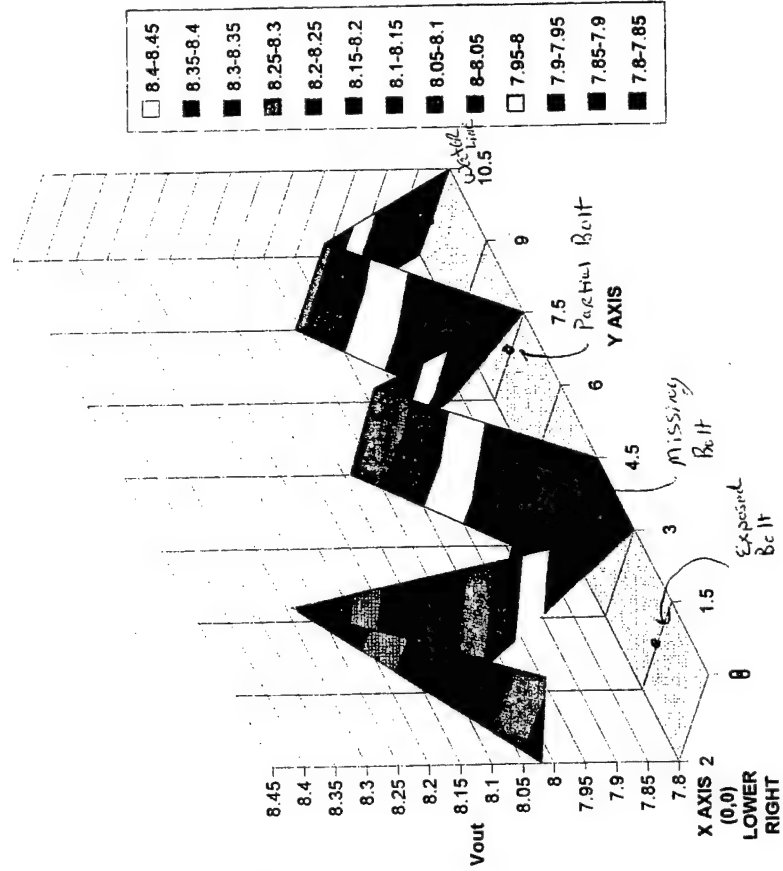
FIGURE 29. Capaciflector Results (Area 4)

In Area 4, under the waterline, the readings were taken at a frame (see Figure 29). There was wood missing from around two of the bolts. In addition, the bolt was exposed at one location at ($y = 1.5$), missing from a second (at $y = 4.5$), and only a partial bolt was located at a third location (at $y = 7.5$). The readings are consistent here as a partial bolt and an empty bolt hole gave lower readings than the intact bolt.

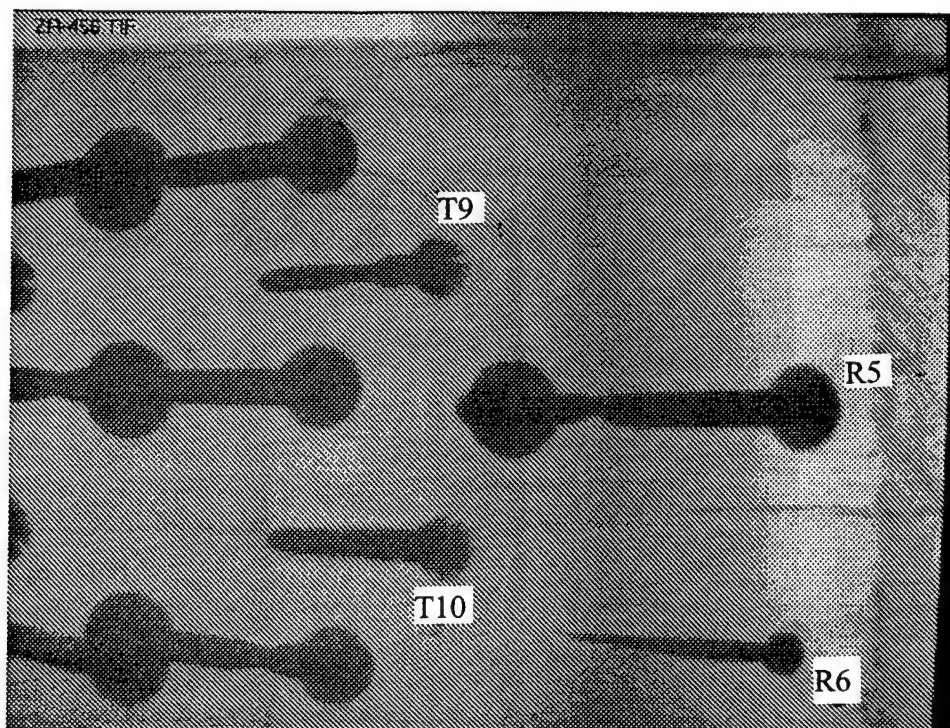
FIGURE 37. Real time X-ray of Test Fixture

In the real time shot (see Figure 37), a more limited area is covered. The results are a positive picture so that this shot is a mirror image of the conventional x-ray. Only fixture fasteners R5 and R4, and Butt 1 fasteners 6 through 10 are covered. The defects are easily seen.
